DOCUMENTING A HISTORIC MOUNTED FIN WHALE SKELETON IN PREPARATION FOR A MOVE—A CASE STUDY AT THE MUSEU DE CIÈNCIES NATURALS DE BARCELONA

Abstract.—In 2009, the Museu de Ciències Naturals de Barcelona launched a new permanent exhibit that included removal and restoration of a landmark piece, a fin whale skeleton, and complete redesign of its assembly structure. In this paper we present the process and results of documenting the piece before the dismantling procedure. A graphic record was created as part of the restoration process, which secondarily served as an important source of information for designing the new mounting system. A detailed visual examination of the skeleton revealed problems in the preservation of the bone. The results of the preparatory examinations proved useful for planning a new preventive conservation program for the piece in its new location.

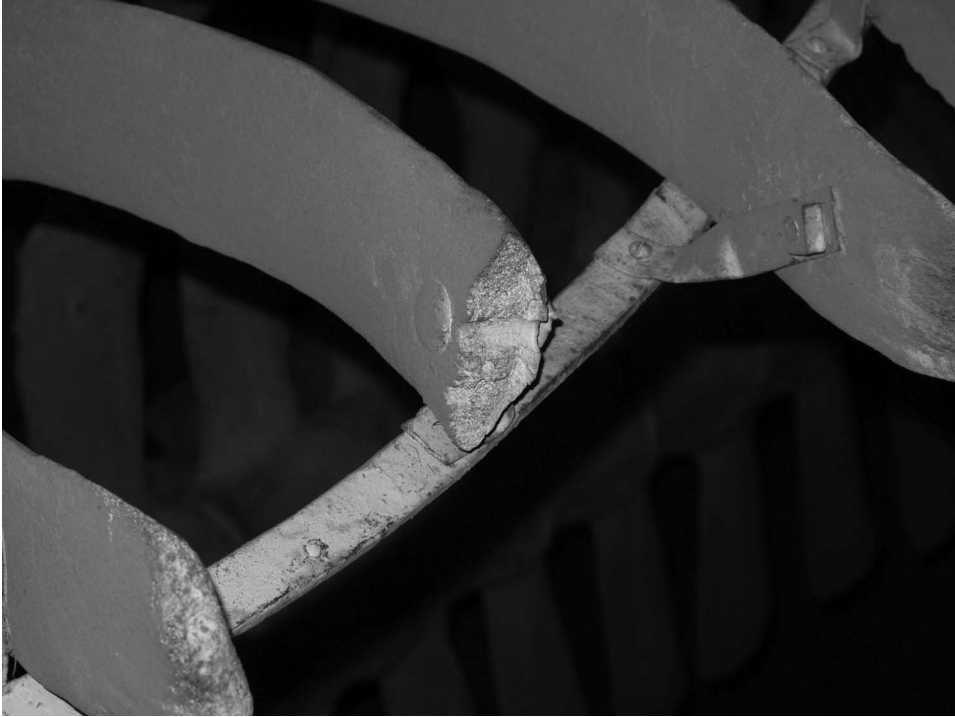
Marked accumulation of dirt (Fig. 8).—Possible causes: low maintenance and periods of poor environmental control in the exhibition area. Periodic cleaning of the piece was not carried out, partly because of the display's inaccessibility once hung from the ceiling. In addition, some bones were covered by white paint that hid layers of dirt and what appeared to be residues of oxidized animal fat (Fig. 9).

Figure 8. Accumulation of dust on the bone surface.

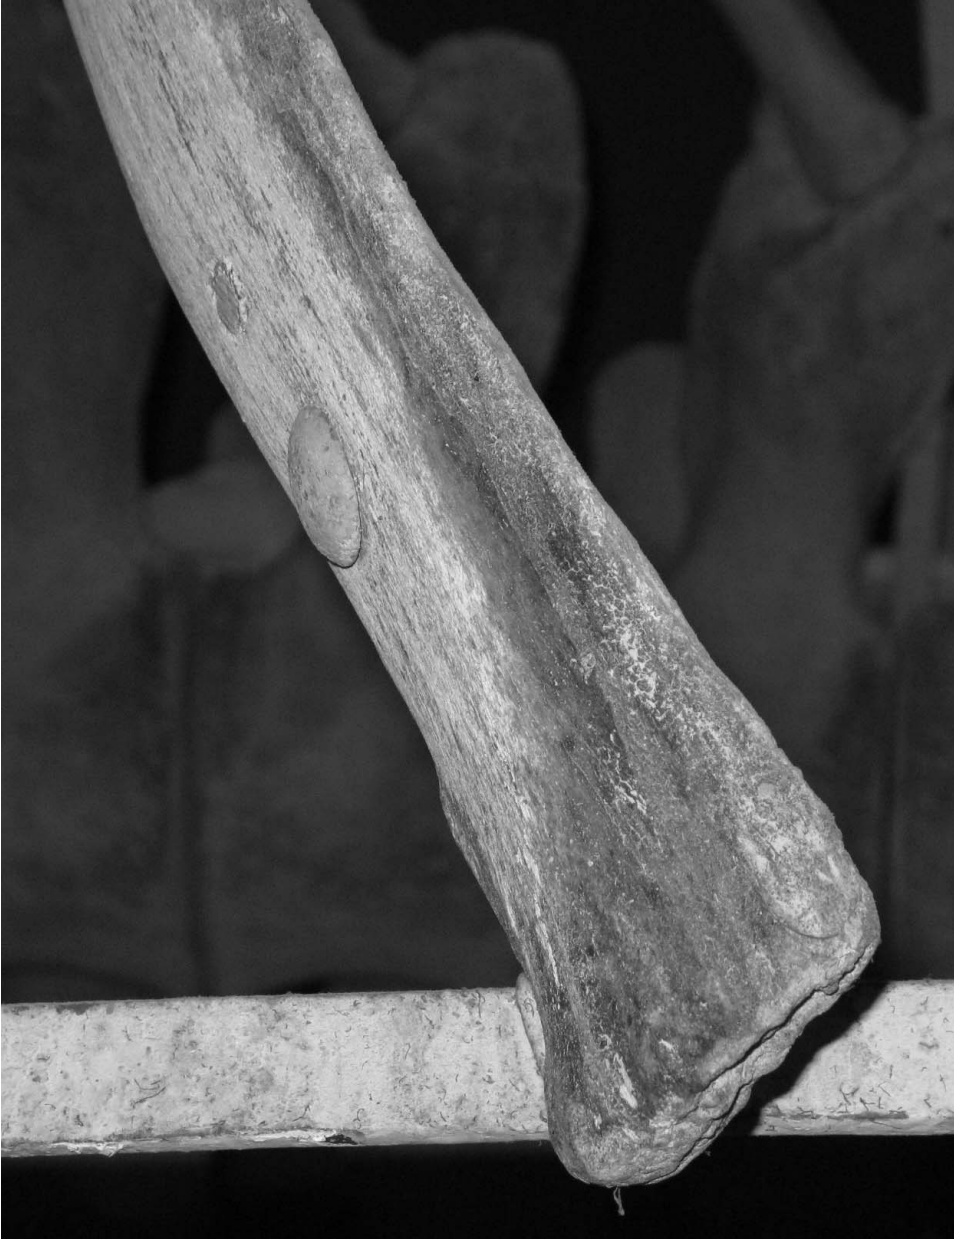
Figure 9. Dirt and oxidized fat visible through a layer of white paint at the end of a rib. ©B. Font—MCNB.

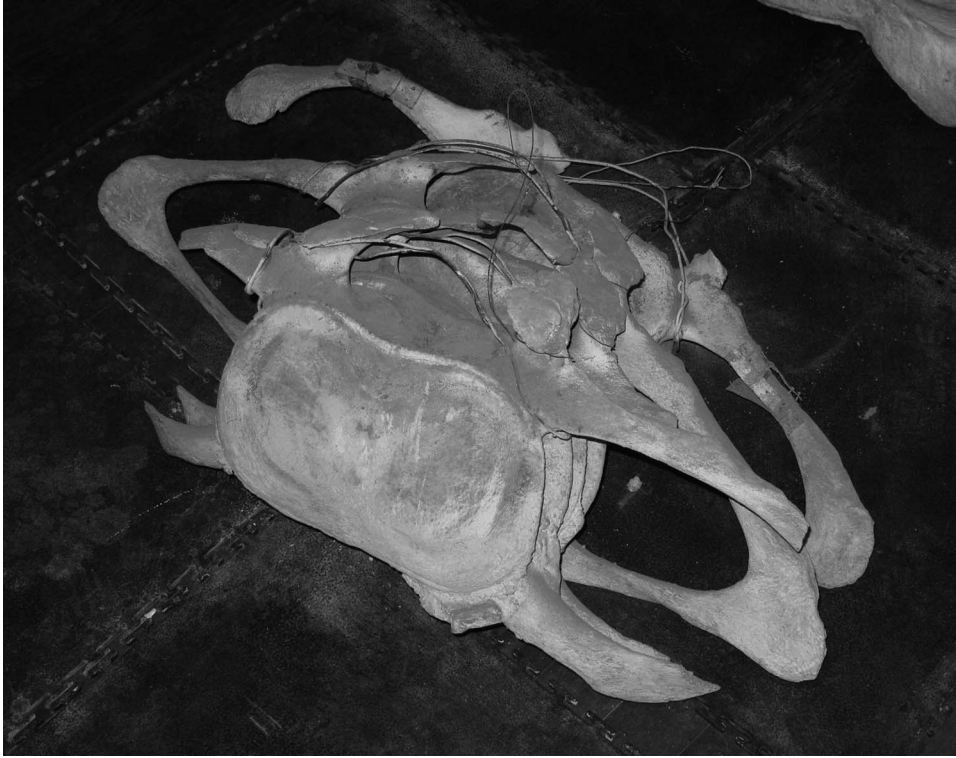
Broken arches of some cervical vertebrae.—Possible cause: improper installation system. The vertebrae are suspended on a bar that passes through the foramen, so arches must hold the weight of the entire vertebra (Fig. 10).

Figure 10. Fractured cervical vertebrae (after removal). ©B. Font—MCNB.

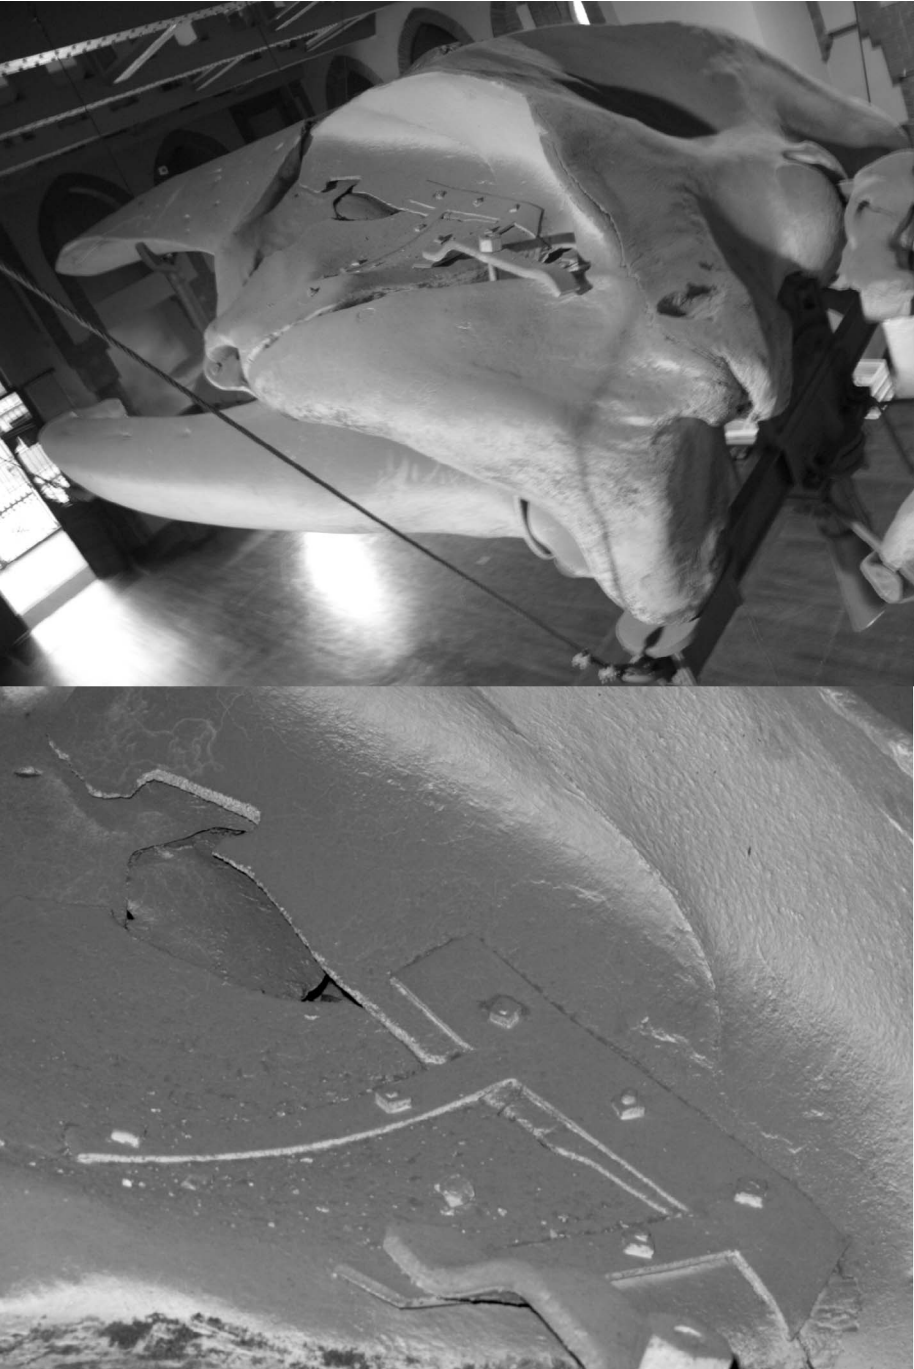
Fracture in the skull repaired by metal plates screwed to the bone.—Some pieces were missing. Possible cause: accident during one of the transfers (Fig. 11).

Figure 11. Overview and detail of the fracture and the repair in the cranium. ©B. Font—MCNB.

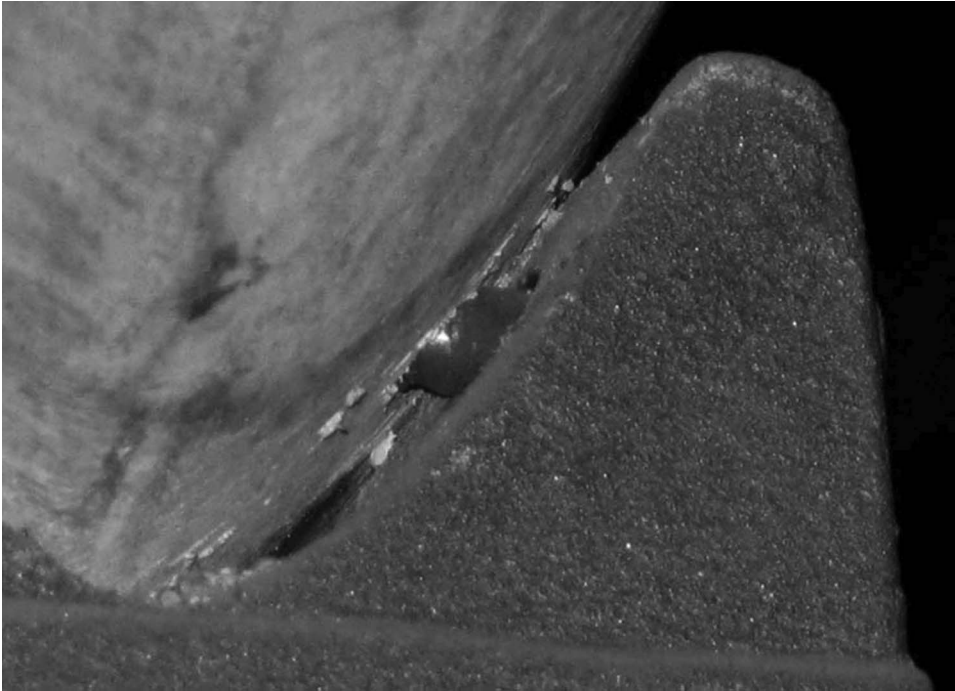
Oxide stains on the bones.—Possible causes: improper assembly materials and nonenvironmental-conditioned exhibition area. Nonstainless metal elements in the struc-

ture are in direct contact with the bones. Corrosion of metallic elements has been accelerated by the absence of environmental control in the exhibition area (Fig. 12).

Figure 12. Oxidized iron bolt, with visible migration of the oxidation products to the bone. ©B. Font—MCNB.
