DOCUMENTING A HISTORIC MOUNTED FIN WHALE SKELETON IN PREPARATION FOR A MOVE—A CASE STUDY AT THE MUSEU DE CIÈNCIES NATURALS DE BARCELONA

Abstract.—In 2009, the Museu de Ciències Naturals de Barcelona launched a new permanent exhibit that included removal and restoration of a landmark piece, a fin whale skeleton, and complete redesign of its assembly structure. In this paper we present the process and results of documenting the piece before the dismantling procedure. A graphic record was created as part of the restoration process, which secondarily served as an important source of information for designing the new mounting system. A detailed visual examination of the skeleton revealed problems in the preservation of the bone. The results of the preparatory examinations proved useful for planning a new preventive conservation program for the piece in its new location.

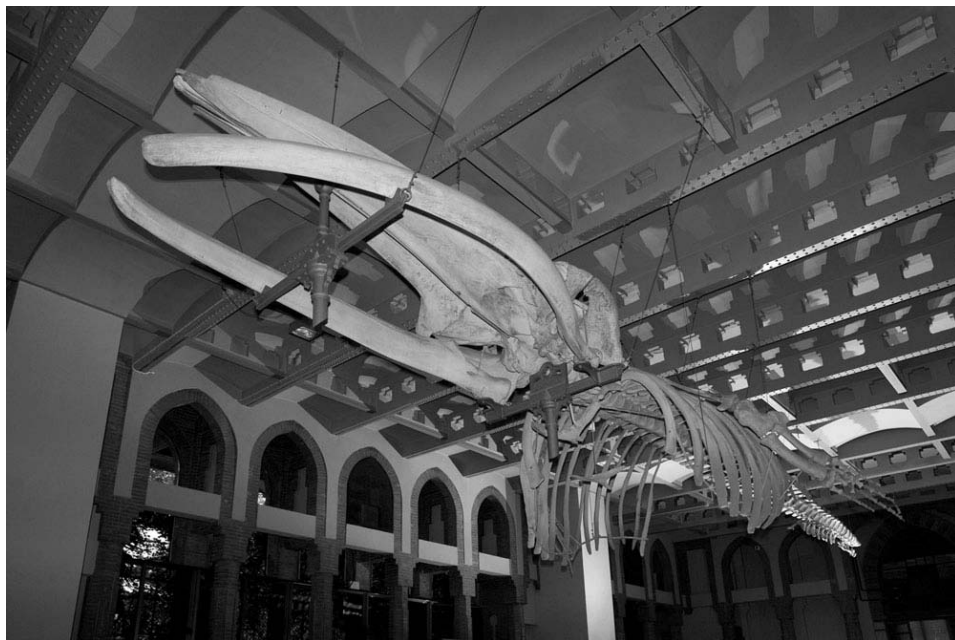
Figure 1. Photograph of the whale skeleton as mounted in the Castell dels Tres Dragons before the dismantling process. ©J. Vidal—MCNB.

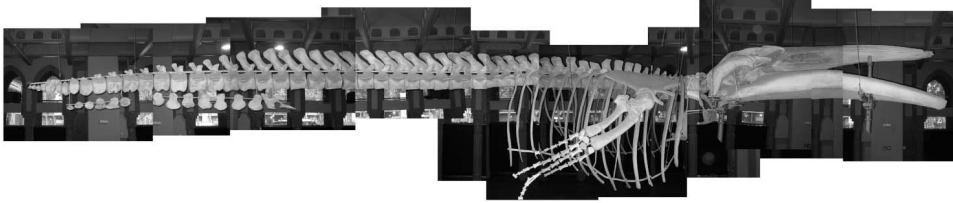
Figure 2. Continuous assembly photomontage of the skeleton. ©B. Font—MCNB.

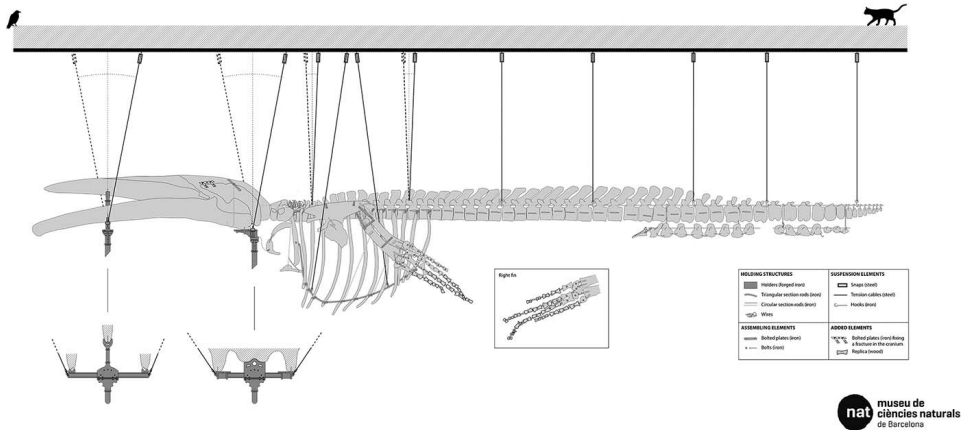
Figure 13 shows a low-definition, black-and-white version of the detailed digital map of the mounting drafted for this study.

Figure 13. Elevation and detail map of the mounted skeleton documenting its position and support structure before the 2010 dismantling. ©M. Pérez—MCNB.
